San Francisco Bay Living Shorelines Project at Giant Marsh,
Point Pinole Regional Shoreline:
Final Summary Report
December 2025

1. Introduction

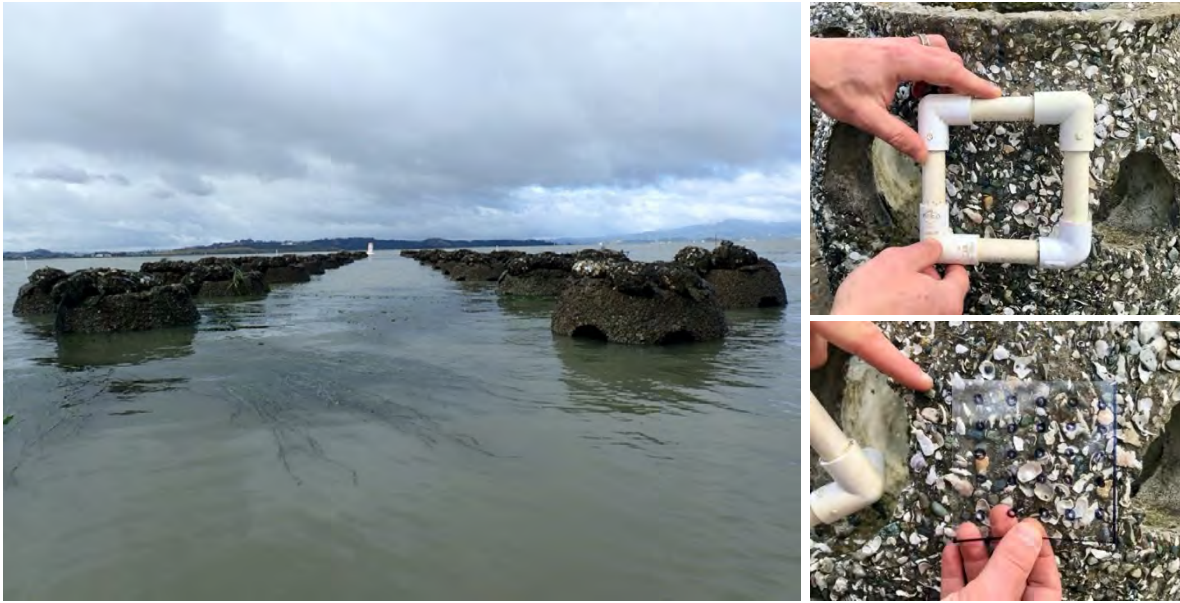
Figure 5. Left: An array of oyster/habitat reefs in Treatment 1, showing reef balls topped with bags of Pacific oyster shell. Eelgrass in the foreground was present prior to the project installation. Right: Monitoring with a quadrat (top) and acetate sheet (bottom).

- Treatment 1 provides the largest amount of oyster restoration substrate for this project, three "reefs" comprising 60 reef balls each (made of 'baycrete'), topped with 2-3 mesh bags of clean Pacific oyster half shell (Fig. 5). This is the deepest of the three treatments (see Fig. 3 for all elevations); bases of the reef balls were placed at -1.6 to -1.7' NAVD88, with the shell bags at about 0' NAVD88. The objective of this treatment with regard to native oysters was to increase the existing population of oysters at Giant Marsh through the provision of hard substrate at a suitable tidal elevation. Based on our results from the living shorelines project at San Rafael, we anticipated that ~0' would be the ideal tidal elevation, and we targeted this height for the shell bags, which provide a greater amount of settlement space per unit area than reef balls. We

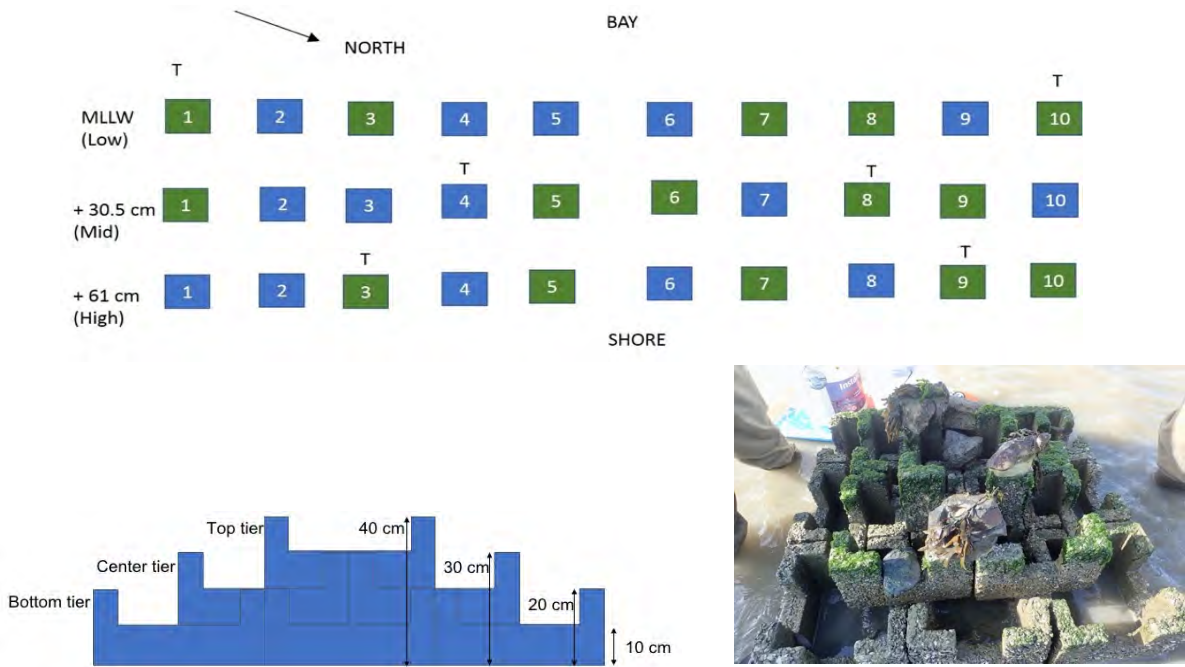
Figure 6. Top: Schematic of the experimental set up for Treatment 2. Green blocks indicate *Fucus* added; blue blocks are controls. “T” designates blocks with temperature loggers. Bottom left: Schematic of a set of oyster blocks, showing the three tiers and height of each tier off the benthos. Bottom right: *Fucus* on cobbles affixed to the top and center elevations of a set of oyster blocks.

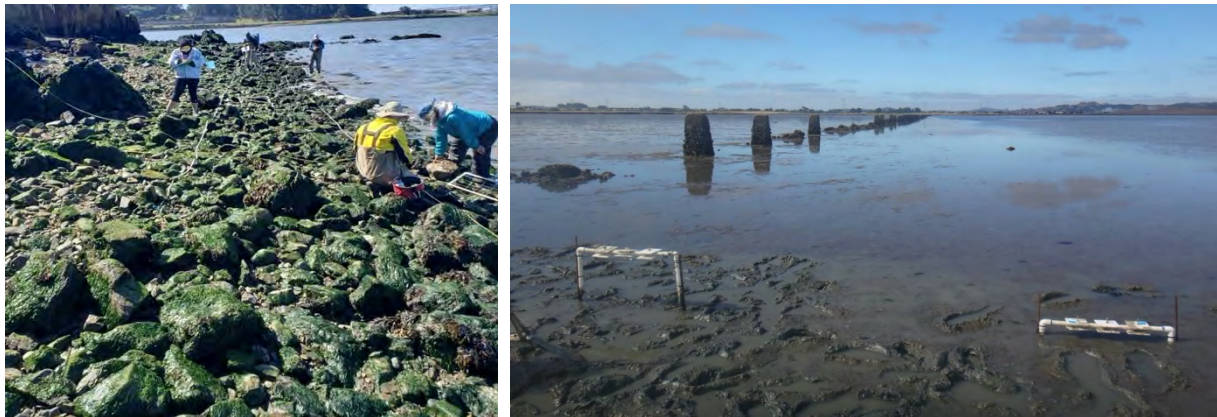
Figure 7. Left: parallel transect lines at Pt. Orient in the *Fucus* (higher) and oyster zone (lower). Right: Recruitment collectors set at two tidal elevations at Giant Marsh.

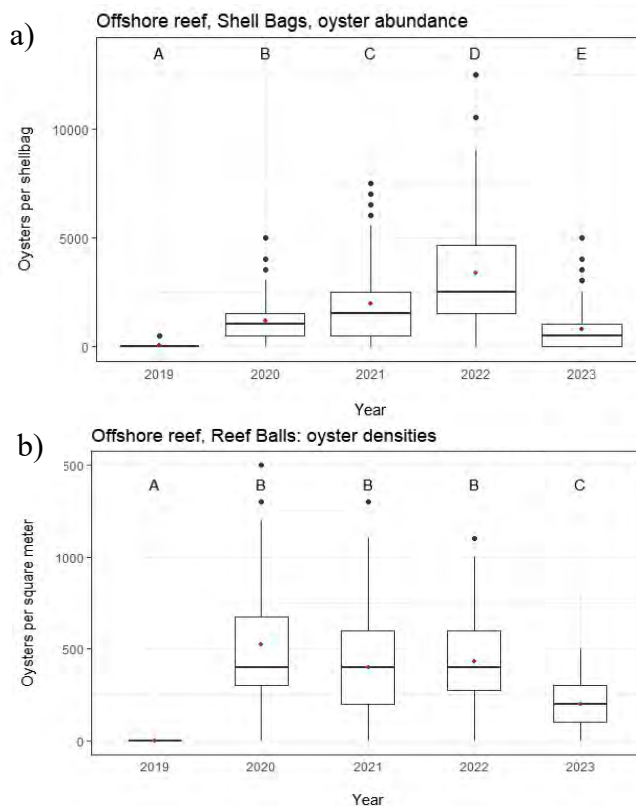
Figure 8. Results of Treatment 1 oyster surveys, 2019-2023. a) Estimated numbers of live oysters per shell bag and b) density of oysters on reef balls from quadrat surveys. Box edges represent the interquartile range of the data; horizontal lines are the median, black dots are outliers, and red dots are the average. Groups that share a letter are not statistically different.

Treatment 1. In August 2019, there were only six oyster recruits (1-3 mm length) from 120 shells in the 12 shell bags examined in the laboratory (Fig. 8). No oysters were found in the quadrat surveys (n=24) in the field. Both the shell bags and reef balls were notably absent of other organisms; surfaces were mostly bare, with a few barnacles, solitary tunicates, encrusting bryozoans and the green seaweed *Ulva* sp. The low number of oyster recruits to Treatment 1 shell bags was not completely unexpected. Spring air and water temperatures were cool in 2019, following a relatively wet winter (See Section 2.7); both factors can delay oyster reproduction in San Francisco Bay (Chang et al. 2016). Oyster recruitment did not begin until late August/early September at other North Bay sites in 2019 (unpublished data from A. Chang and A. Deck). In addition to less-than-optimal conditions in 2019, the historically heavy rains in winter 2017 decimated oyster populations in the North Bay in particular, and populations had still not recovered to pre-2017 levels (authors' unpublished

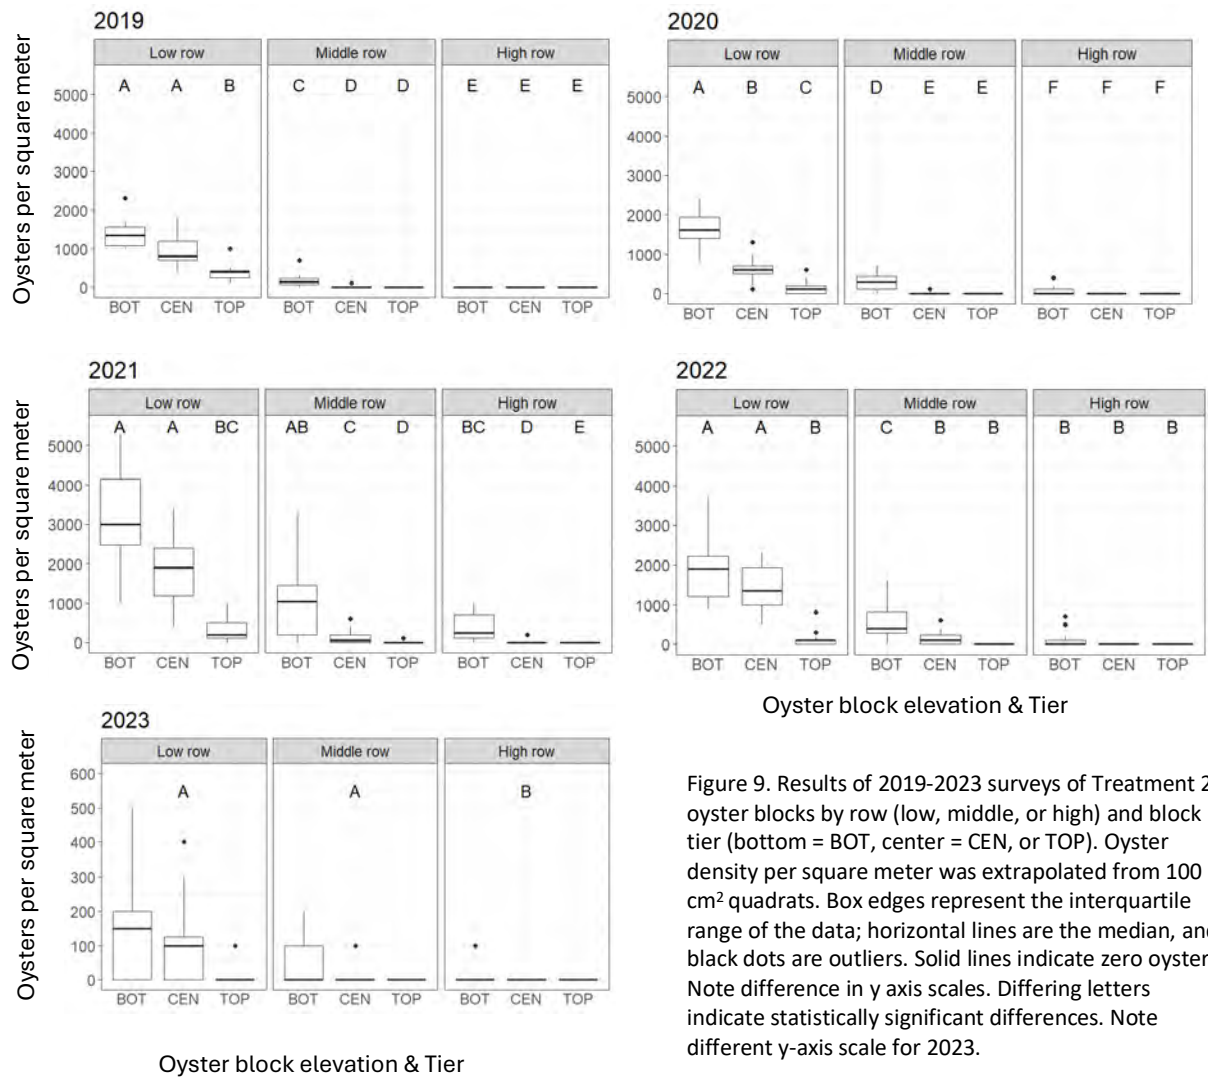
Figure 9. Results of 2019-2023 surveys of Treatment 2 oyster blocks by row (low, middle, or high) and block tier (bottom = BOT, center = CEN, or TOP). Oyster density per square meter was extrapolated from 100 cm² quadrats. Box edges represent the interquartile range of the data; horizontal lines are the median, and black dots are outliers. Solid lines indicate zero oysters. Note difference in y axis scales. Differing letters indicate statistically significant differences. Note different y-axis scale for 2023.

Treatment 2: Oyster responses. From 2019-2021 the densities of oysters increased across Treatment 2 (Fig. 9). In 2022, oysters declined somewhat, with losses mainly on the higher two intertidal rows. In 2023, following the wet winter, oyster densities decreased by an order of magnitude (Fig. 9, Table 2).

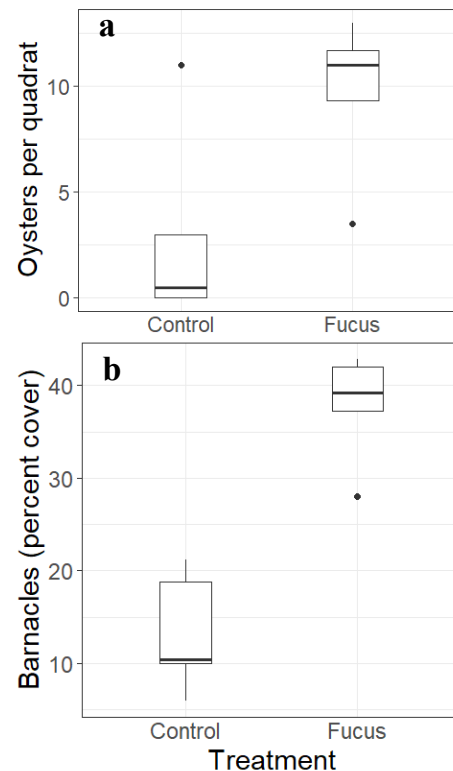
Figure 10. Effect of *Fucus* canopy on a) oyster densities, and b) percent cover of barnacles.

Temperatures measured while *Fucus* was still abundant in July 2021 were lower, and relative humidity was higher, under *Fucus* relative to bare controls on the low row (Zabin and Blumenthal 2024). Strikingly, *Fucus* had a positive, statistically significant effect on both oyster and barnacle density (Fig. 10), with ~three times more oysters (Wilcoxon rank sum test $W = 2.5$, $p = 0.046$) under *Fucus* compared to control cobbles with no *Fucus* and ~three times greater barnacle cover (Wilcoxon rank sum test $W = 1$, $p = 0.016$). Oyster sizes were not

affected by *Fucus* cover (Wilcoxon rank sum test $W = 8, p=1$). *Ulva* was abundant (70% cover) on controls and absent under *Fucus*. Although the mechanism for these community-level differences isn't completely known, the data indicate that *Fucus* modifies conditions in the under-canopy microhabitat and influences sessile community development in a way that benefits oysters.

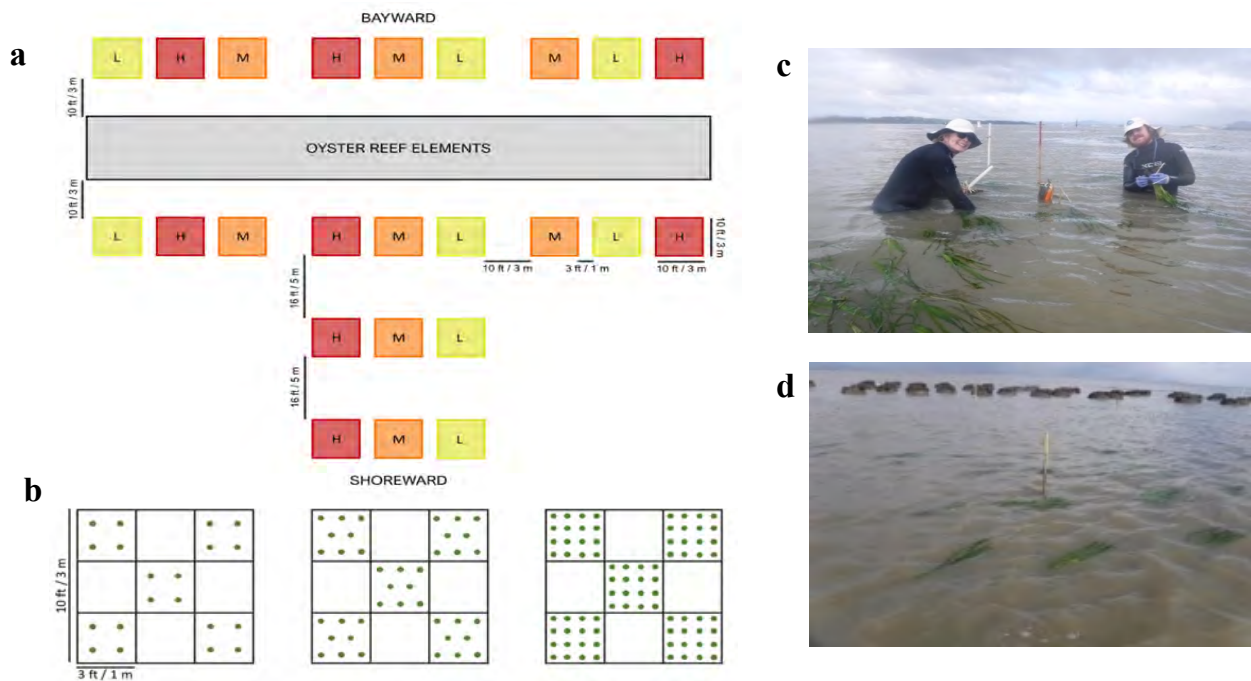
Figure 11. a) Example of the configuration of an oyster-eelgrass combined array in Treatment 1. Planting density arrangement varied at each oyster reef; densities are represented as high ('H', red) for 40 shoots m^{-2} , medium ('M', orange) for 20 shoots m^{-2} , and low ('L', yellow) for 10 shoots m^{-2} . Configurations of the eelgrass only plot arrays duplicated the shoreward row nearest to the oyster reef of the adjacent eelgrass-oyster unit to the south. b) Schematic representing planted eelgrass plots in the densities above, with low to high from left to right. Green dots represent planting units containing 2-3 shoots each. c) Planting eelgrass. d) Immediately after planting.

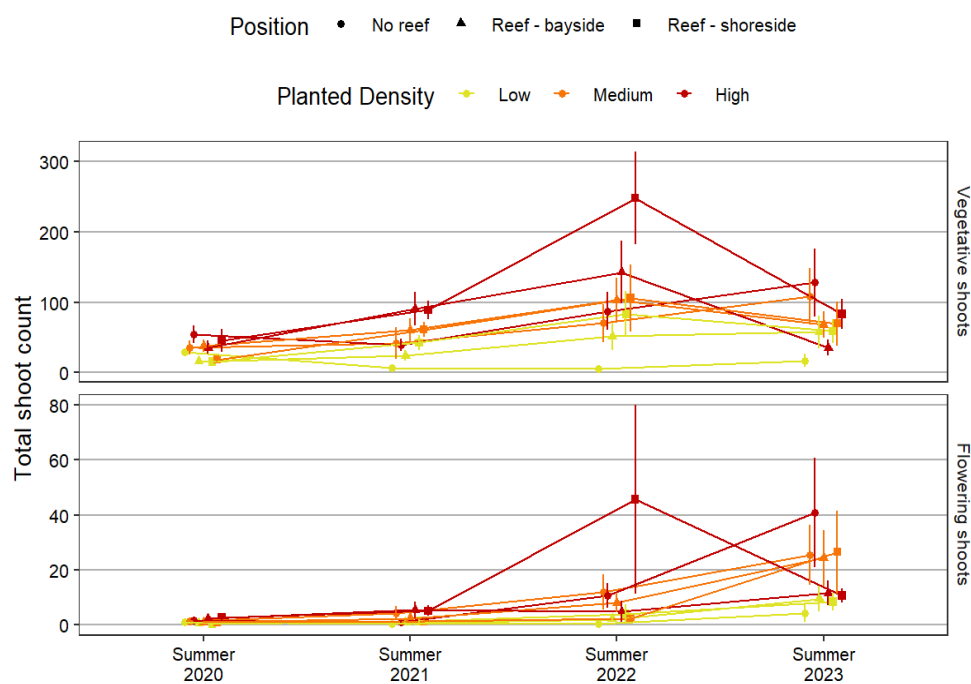
Figure 12. Mean total eelgrass vegetative and flowering shoots by planted density and location relative to reefs in summer 2019 – 2023. Summer 2022 and 2023 total shoot counts were estimated through shoot density and patch sizes. Error bar show ± 1 standard error. Mid and far plots shoreward of reefs (See Fig. 3 and 11a) not included (See Fig. 13 for those results).

Beginning in 2021, we began to see evidence that planting eelgrass more densely led to increased densities and total number of shoots present, and these patterns continued through the final summer (2023) of monitoring (see density in Buchbinder 2025a; total shoots by position and planting density in Fig. 12). Importantly, the magnitude of the difference was not proportional to the initial difference in planting density, indicating that the benefits of planting densely must be weighed with the increased

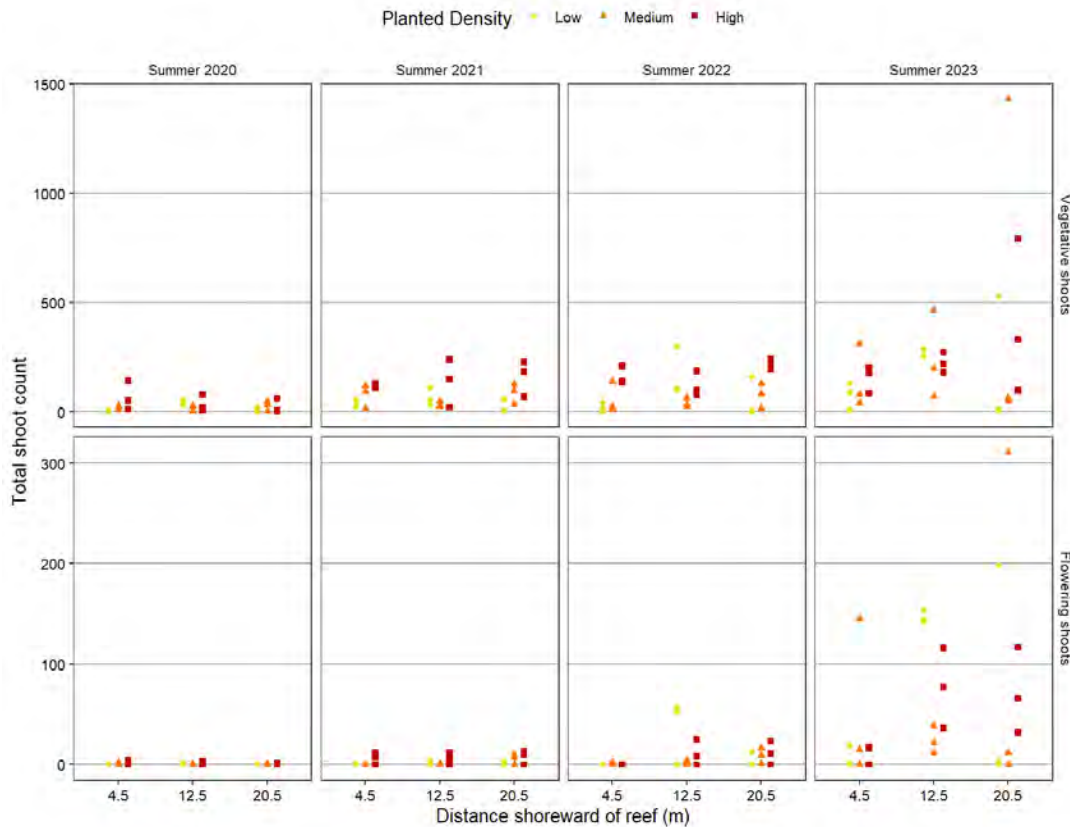
Figure 13. Eelgrass total vegetative and flowering shoots by distance shoreward of the reefs in summer 2020 – 2023. Plot includes data from the shoreside near, mid and far locations (See design in Figs. 3 and 11a); for the near location, only the three center plots were included. Total shoots were calculated from patch sizes and densities in 2022 and 2023, when there were too many shoots to count.

Further, significant increases in shoot counts (Fig. 13) and vegetated patch area in 2023 in plots further shoreward of the reefs, at the mid and far positions (See planting design in Figs. 3 and 11a), indicate that reefs may provide benefits to eelgrass located upwards of 20 m shoreward of the reef. In contrast, the

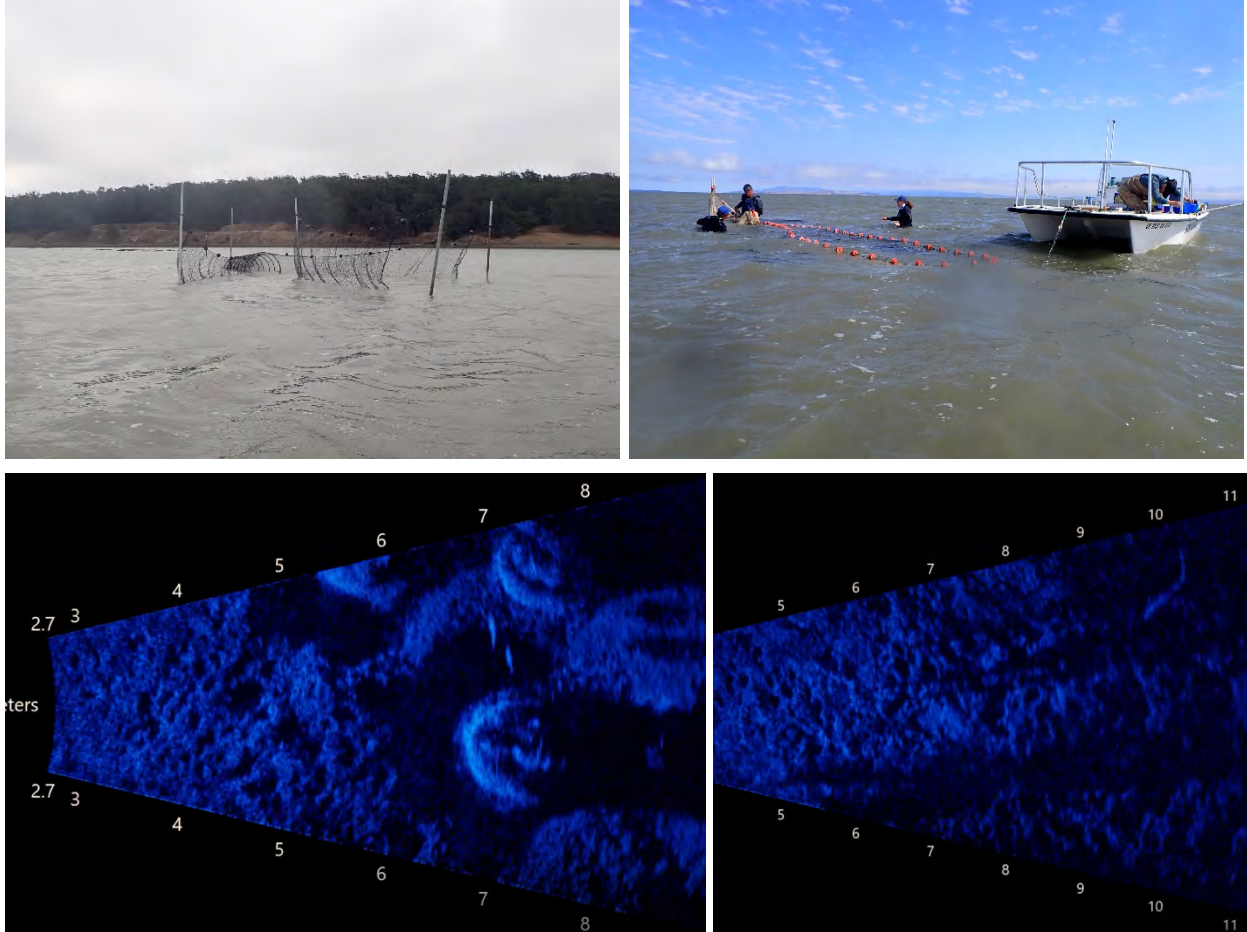
Figure 16. Photographs of A) Hoop net deployed adjacent to reefs at Giant Marsh; B) FISHBIO staff and SFSU student and staff bring in a seine; C) ARIS imagery showing fish swimming between oyster reefs; and D) ARIS imagery showing a leopard shark swimming in eelgrass.

We included multiple methods of fish sampling (Fig. 16) to maximize understanding of fish usage considering known limitations of each technique singly (Buchbinder et al. 2025a, Eschenroeder et al. 2022). We found hoop nets captured larger fish on average than seines, which represented fish of a broader number of sizes, while eDNA picked up additional species not detected by other methods. No strong patterns were detected by treatment, but there was a trend of greater catch per unit effort (CPUE) in restored eelgrass with hoop nets and in natural eelgrass with seines. ARIS sonar captured more fish than physical sampling methods, and showed a trend of greater CPUE in eelgrass associated with reefs compared to restored eelgrass alone. However, neither had a greater CPUE than in bare mudflat, thus we were not able to demonstrate a 50% increase in fish visits to the Treatment 1 reefs and eelgrass relative to control areas with no physical structure, as specified by the success criteria. Overall, we see fish sampling as an ongoing challenge in the complex structures of living shorelines projects.

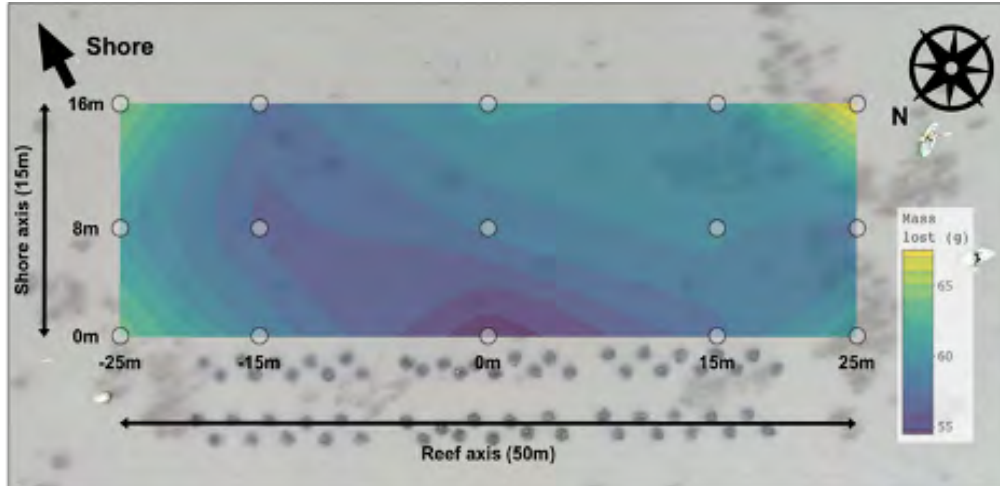
Figure 17. 'Heat map' showing plaster mass loss overlaid on drone imagery (from August 2020) in winter 2020. Darker colors show lower mass lost. Circles indicate locations of plaster blocks during deployment.

Relative water motion measured via plaster block dissolution in winter 2020 showed that flow was reduced by 36% shoreward and close to the reefs, declining to 17% and 6% by 8 and 16 m shoreward of the reef, respectively (Fig. 17). Such effects were not detected in a summer 2020 plaster block deployment, perhaps due to overall higher wave energy in the summer or presence of developing eelgrass patches obscuring reef effects.

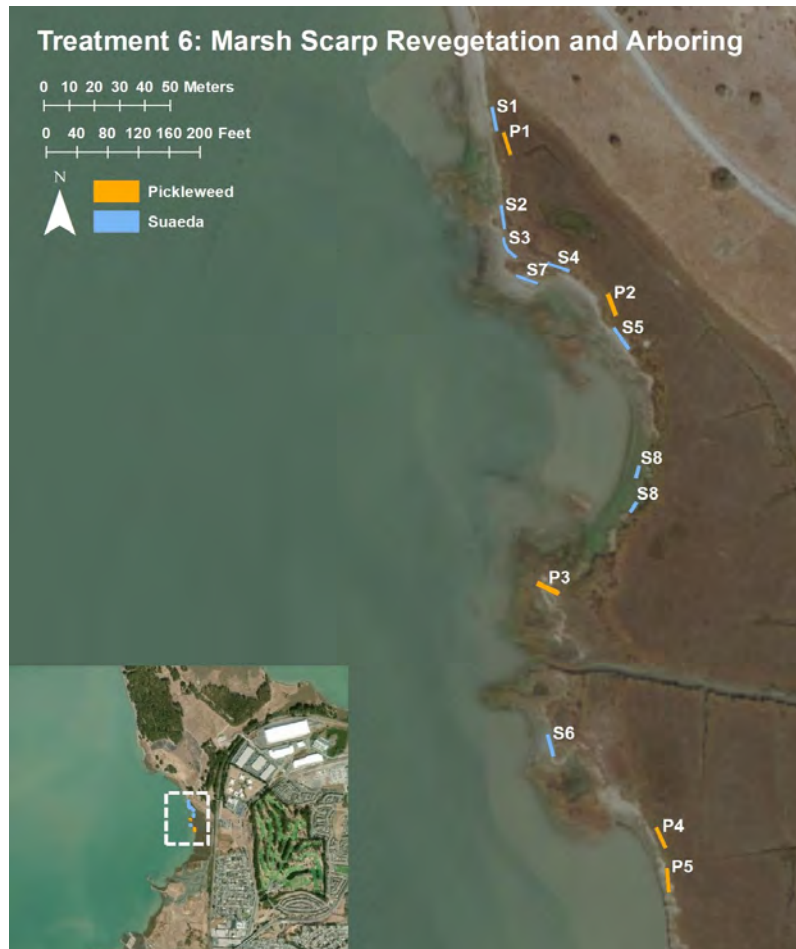
Figure 21. Map of Treatment 6 sea-blite (*Suaeda californica*) blocks (S1 – S8 in blue) and pickleweed (*Salicornia pacifica*) blocks (P1-P5 in orange). Sea-blite blocks noted include the full arboing and wrack treatments in their crossed design; additional plantings after 2020 (that did not follow this design) not shown.

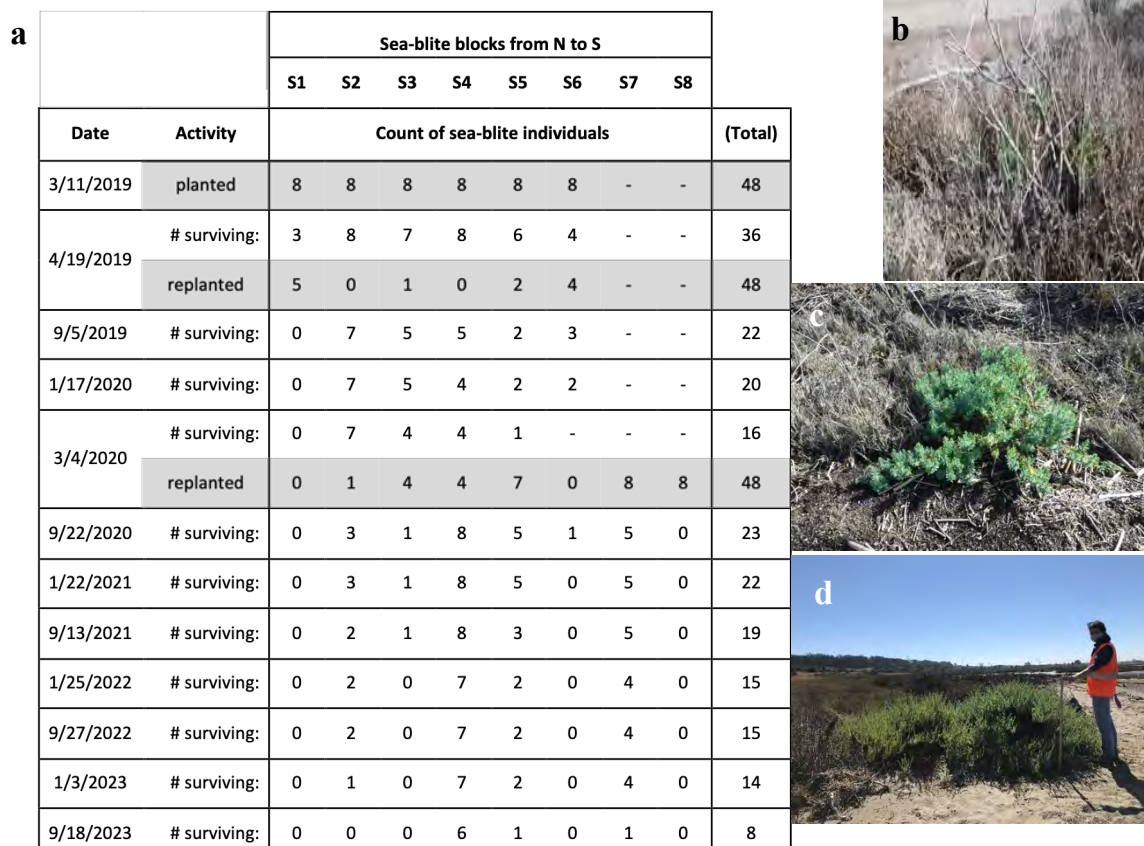
Figure 22. a) Timeline of planting and survivorship of sea-blite in the eight blocks planted with the full experimental design in 2019 and 2020, b) a sea-blite plant beginning to climb an arbor, January 2020, c) a bright blue-green individual that had been treated with wrack in the planting hole, and d) an arbored plant at right with meter stick for scale, and an un-arbored plant at left, September 2020.

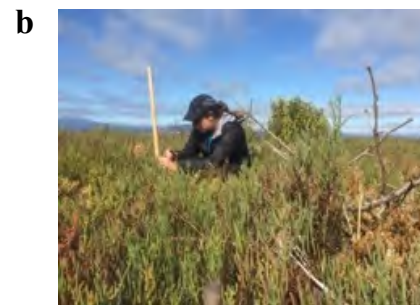
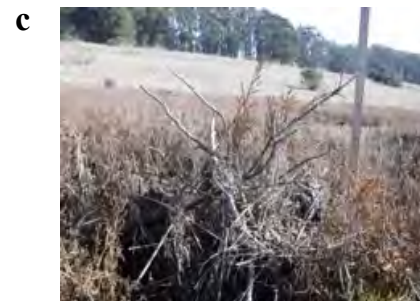
Figure 24. a) Pickleweed canopy height across paired treatment and control points, 2019 - 2023. Each point represents canopy height at a pair of measurement points, with control points on the x axis, and adjacent arbored point on the y axis. The diagonal line is $y = x$. Points falling above this line represent pairs where the arbored plant was taller. Colors represent blocks (See Fig. 21). Absence of points indicates a loss of the arbored pair, due to shoreline erosion or sediment deposition over the arbor and/or control point. b) Pickleweed climbing an arbor in September 2019 and c) in January 2020.

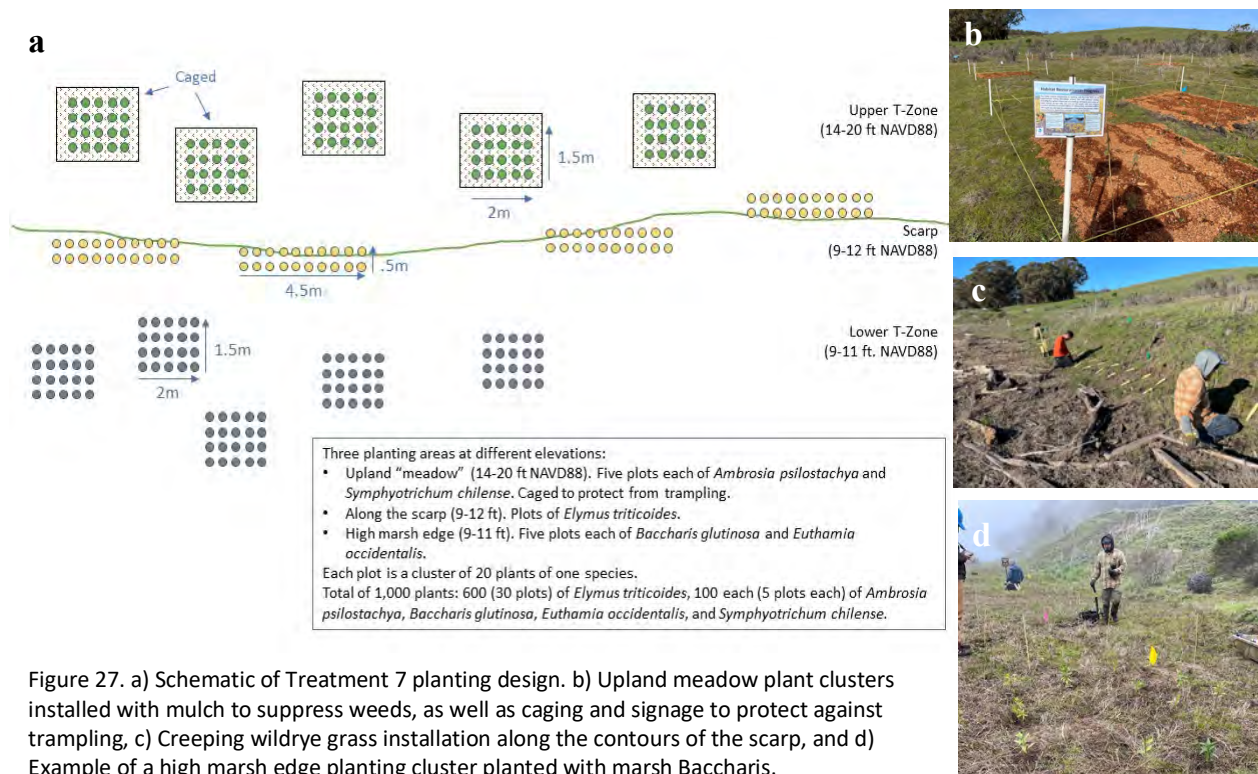
Figure 27. a) Schematic of Treatment 7 planting design. b) Upland meadow plant clusters installed with mulch to suppress weeds, as well as caging and signage to protect against trampling, c) Creeping wildrye grass installation along the contours of the scarp, and d) Example of a high marsh edge planting cluster planted with marsh *Baccharis*.

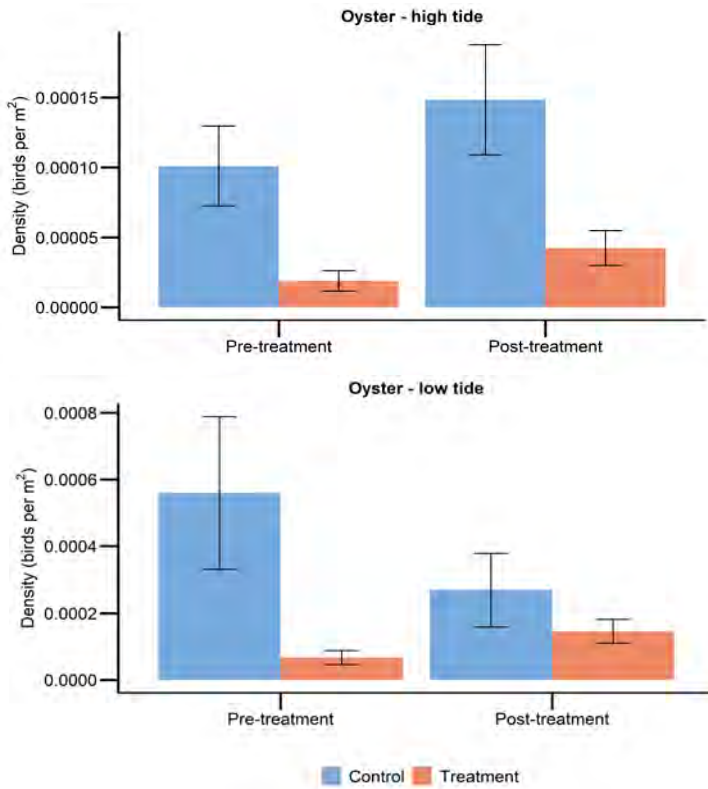
Figure 29. Mean waterbird densities (\pm SE) in paired control and treatment grid cells for the Treatment 2 and 3 oyster/habitat reef additions at (a) high and (b) low tides before (pre-treatment) and after (post-treatment) installation of reefs.

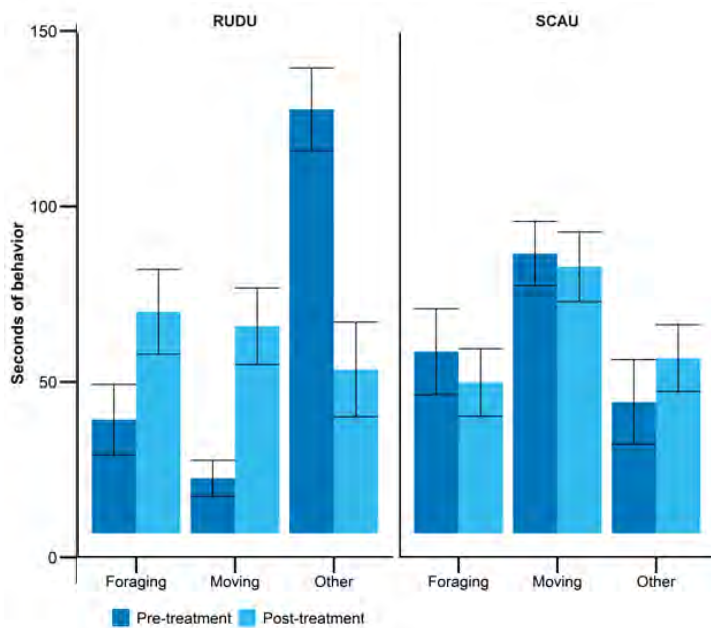
Figure 30. Mean duration in seconds (\pm standard error) of three behaviors (foraging [diving], moving, and other) exhibited by ruddy duck (RUDU), and greater and lesser scaup (SCAU) during the pre- and post-treatment periods in Giant Marsh study area at low tide.

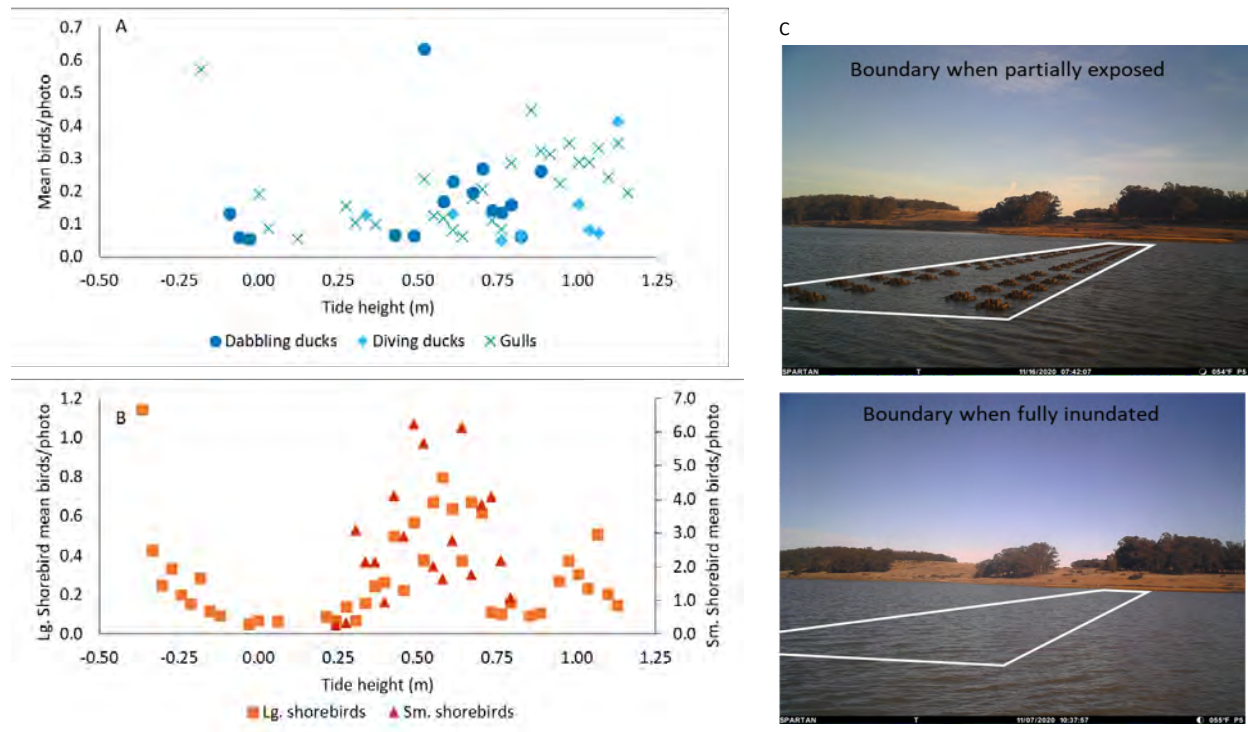
Figure 31. Mean number of birds observed per photo by tide height (m) for each of the five most abundant guilds observed at the Treatment 3 nearshore reef. A) Dabbling ducks – dark blue circles; Diving ducks – blue diamonds; Gulls – blue X. B). Large shorebirds (orange squares) are plotted on the left Y-axis, and small shorebirds (red triangles) on the right Y-axis. Note: Y-axes differ in scale. C) A view of the Treatment 3 nearshore reef when partially exposed versus fully inundated.

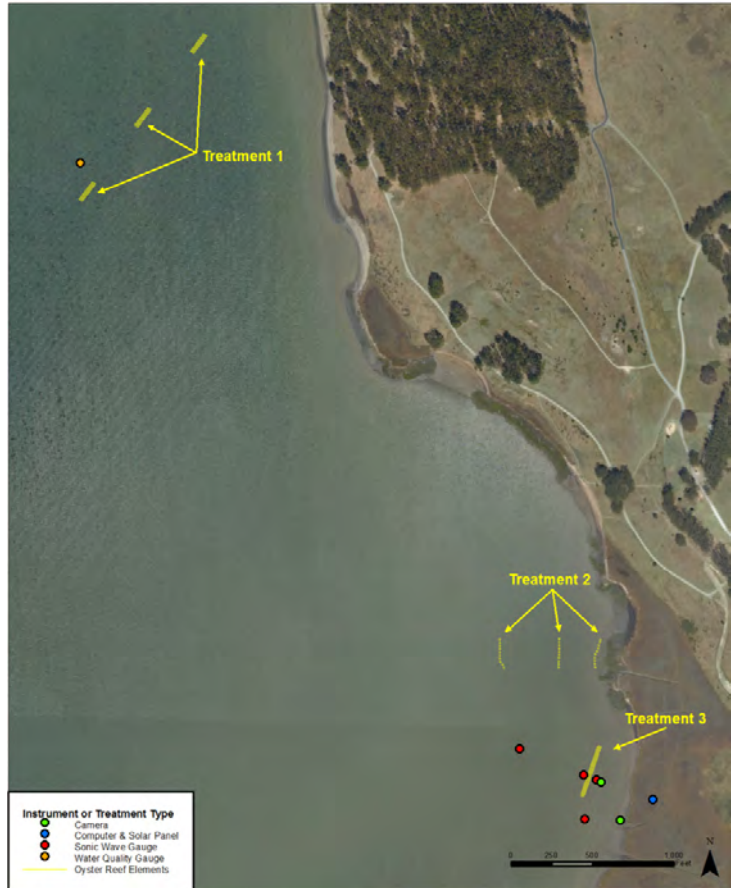
Figure 32. Physical processes instrument deployment locations.

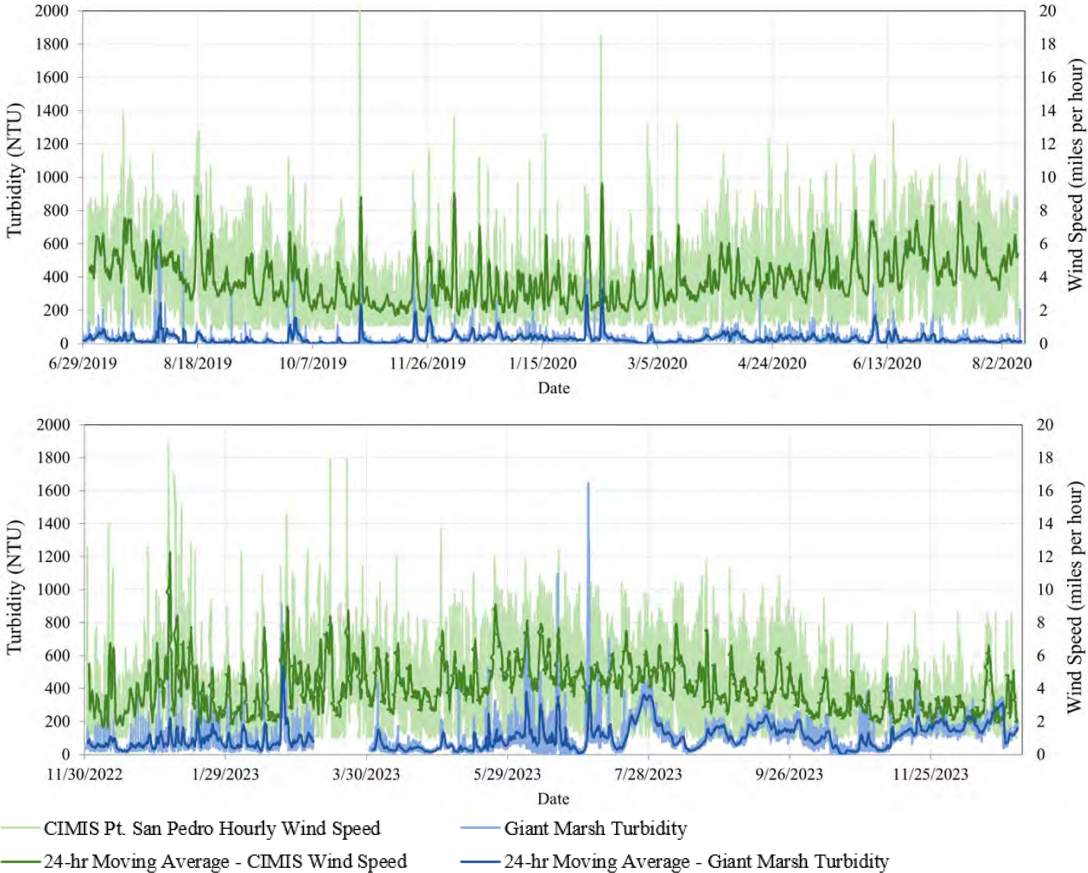
Figure 35. Turbidity measured by the sonde at Giant Marsh Treatment 1 in comparison to wind speed measured at the CIMIS Pt. San Pedro station.

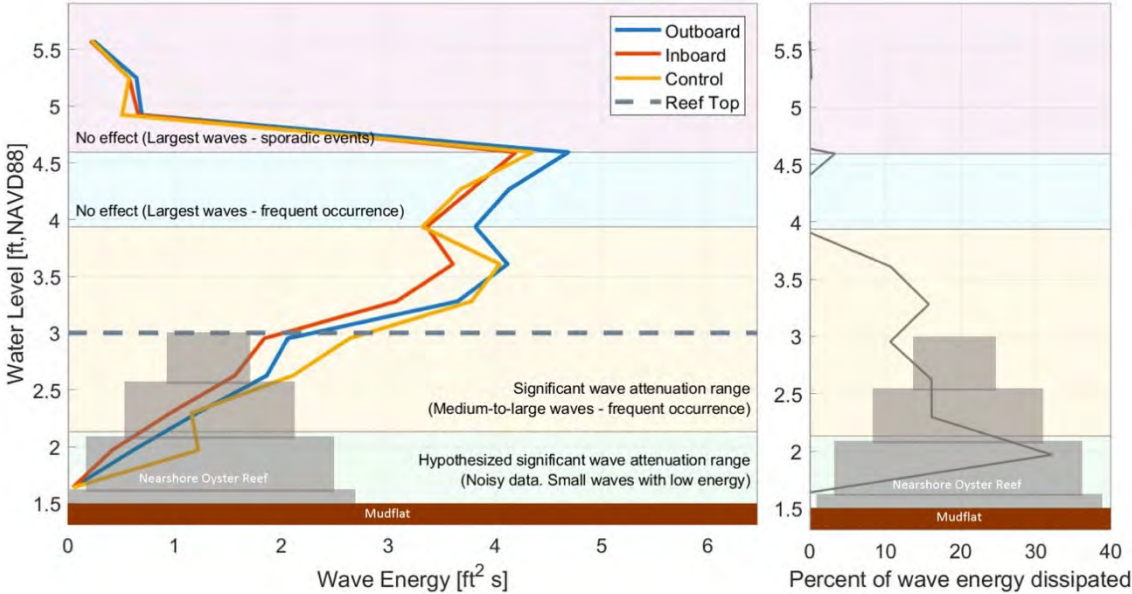
Figure 36. Wave energy distribution and nearshore oyster reef wave dissipation potential as a function of water depth outboard and inboard of Treatment 3 reef and compared to control sensors.
